The Road Inventory of Browns Park National Wildlife Refuge Maybell, CO

Prepared By:
Federal Highway Administration
Central Federal Lands Highway Division
May 2008

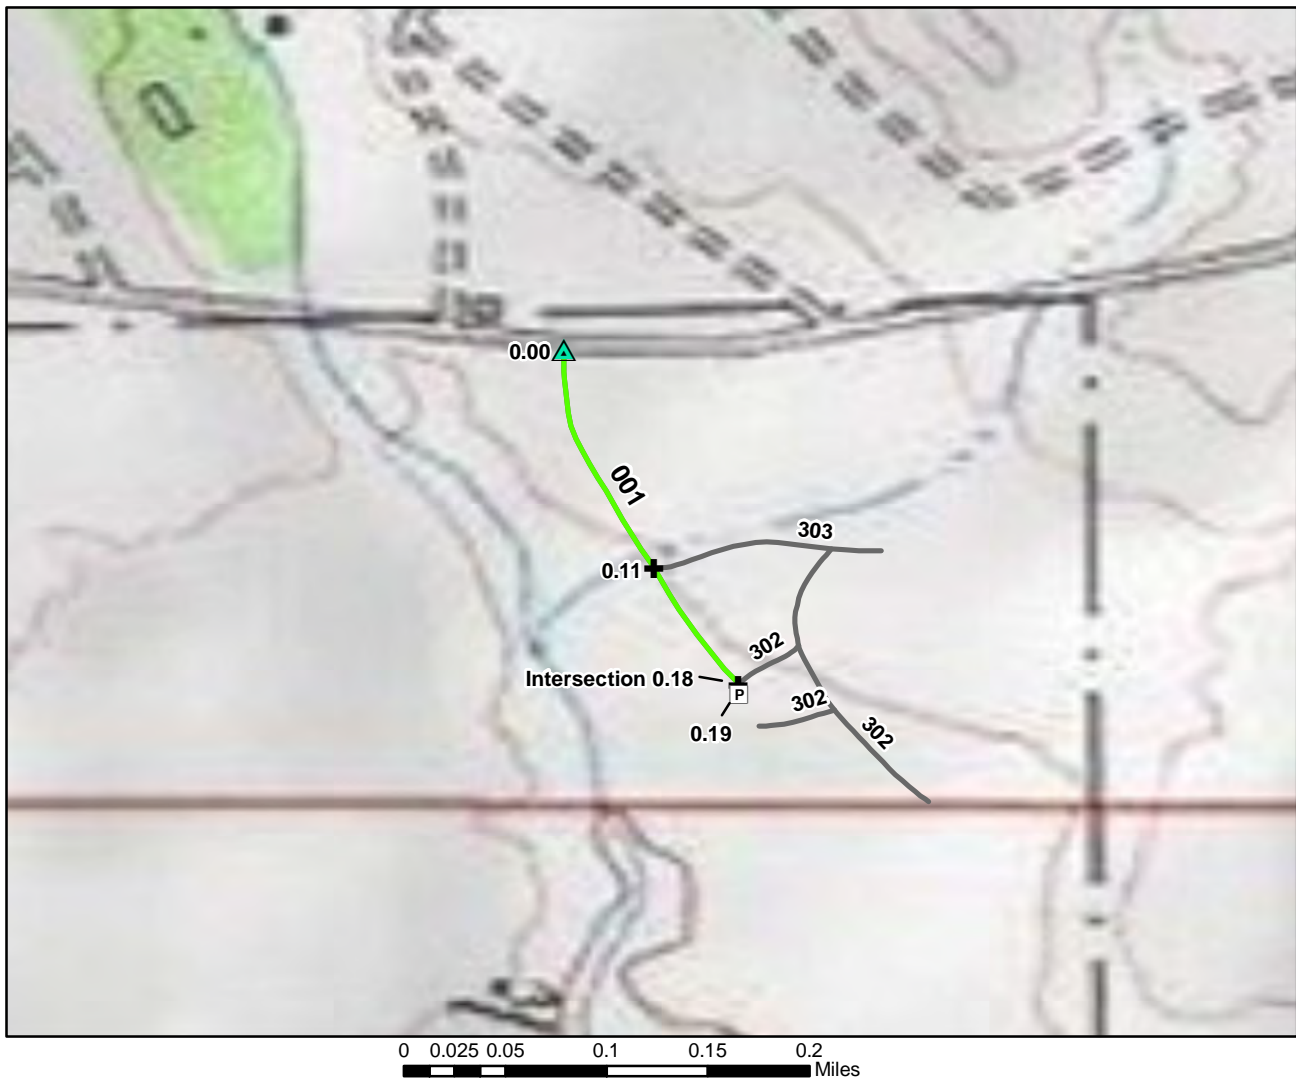
ROUTE: 010 Wildlife Drive Road TOTAL LENGTH: 7.78 Miles

Section Number	006	007	008		
Section Length (miles)	1.02	1.02	0.70		
Inspection Date	5/1/2008	5/1/2008	5/1/2008		
Section Information					
Surface Type	Gravel	Gravel	Gravel		
Number of Lanes	2	2	2		
Roadway Width (feet)	18	18	18		
Roadway Condition Information					
Condition	Good	Good	Good		
Remaining Service Life (years)	7	7	7		
Cost Estimate	\$1600	\$1600	\$1100		
CRV	\$662600	\$660900	\$452500

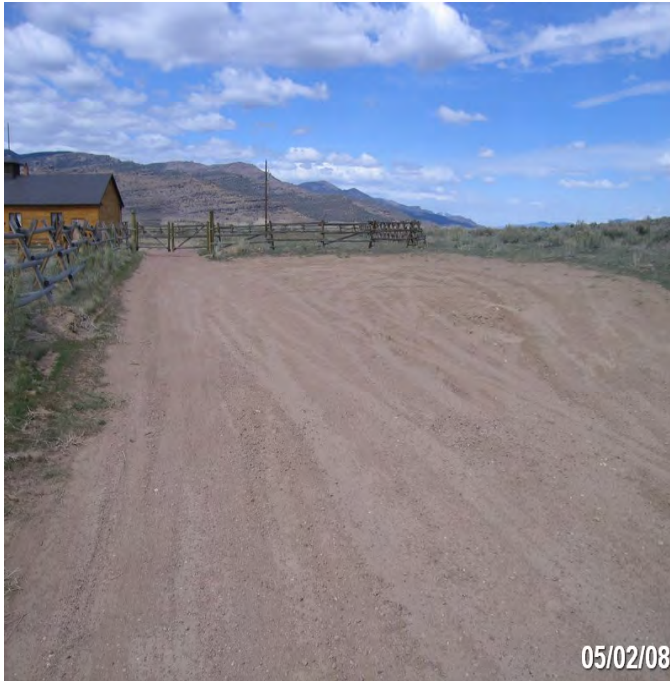
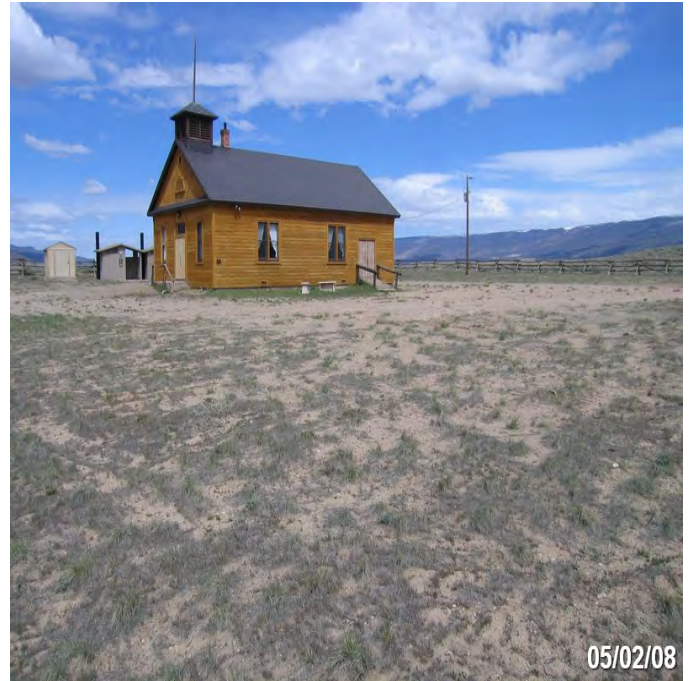
Asset Number	Date Visited	Surface Type	Area (sq ft)	Condition	Cost to Improve
10053315	5/2/2008	Gravel	5895	Poor	\$51400

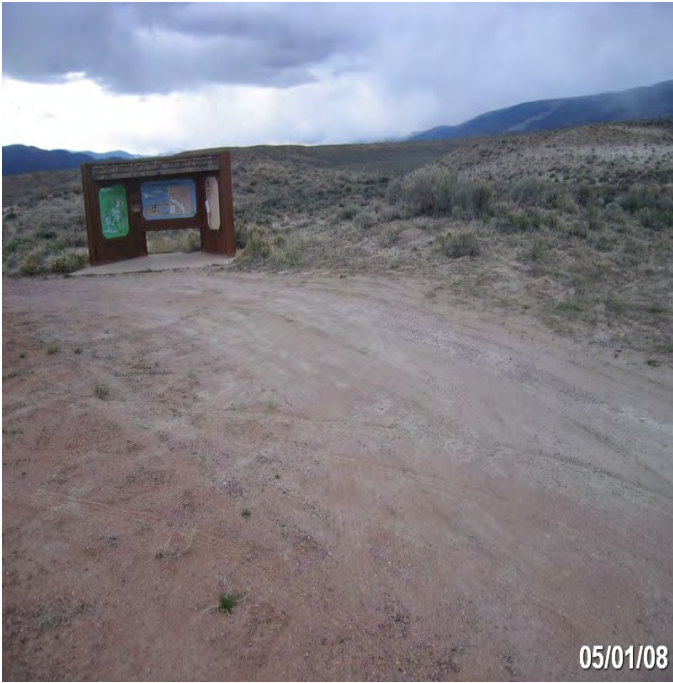
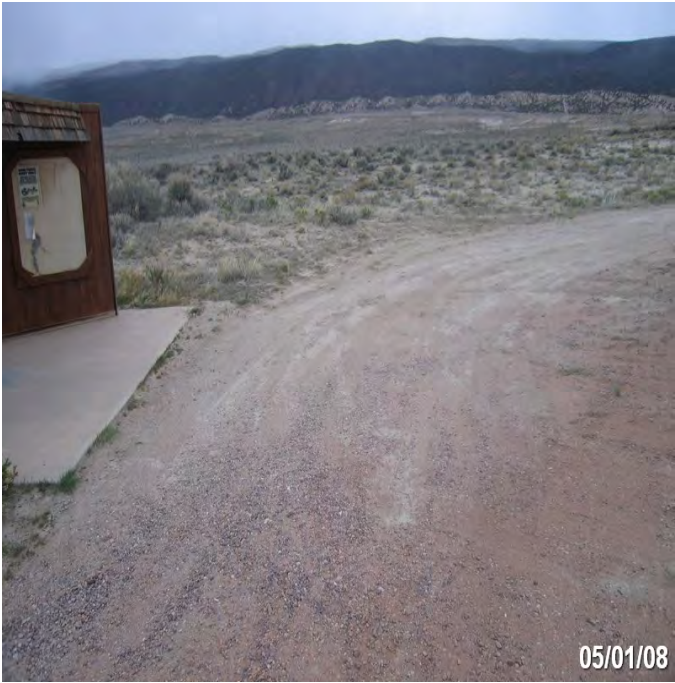
Asset Number	Date Visited	Surface Type	Area (sq ft)	Condition	Cost to Improve
10053317	5/1/2008	Gravel	1827	Poor	\$1900
